## GETTING COLD FEET – FROST HEAVE OF A REFRIGERATED WAREHOUSE FLOOR

Investigation and analysis by ESi resulted in a favorable verdict at trial for the owner of a refrigerated warehouse following a frost heave failure of the warehouse floor.

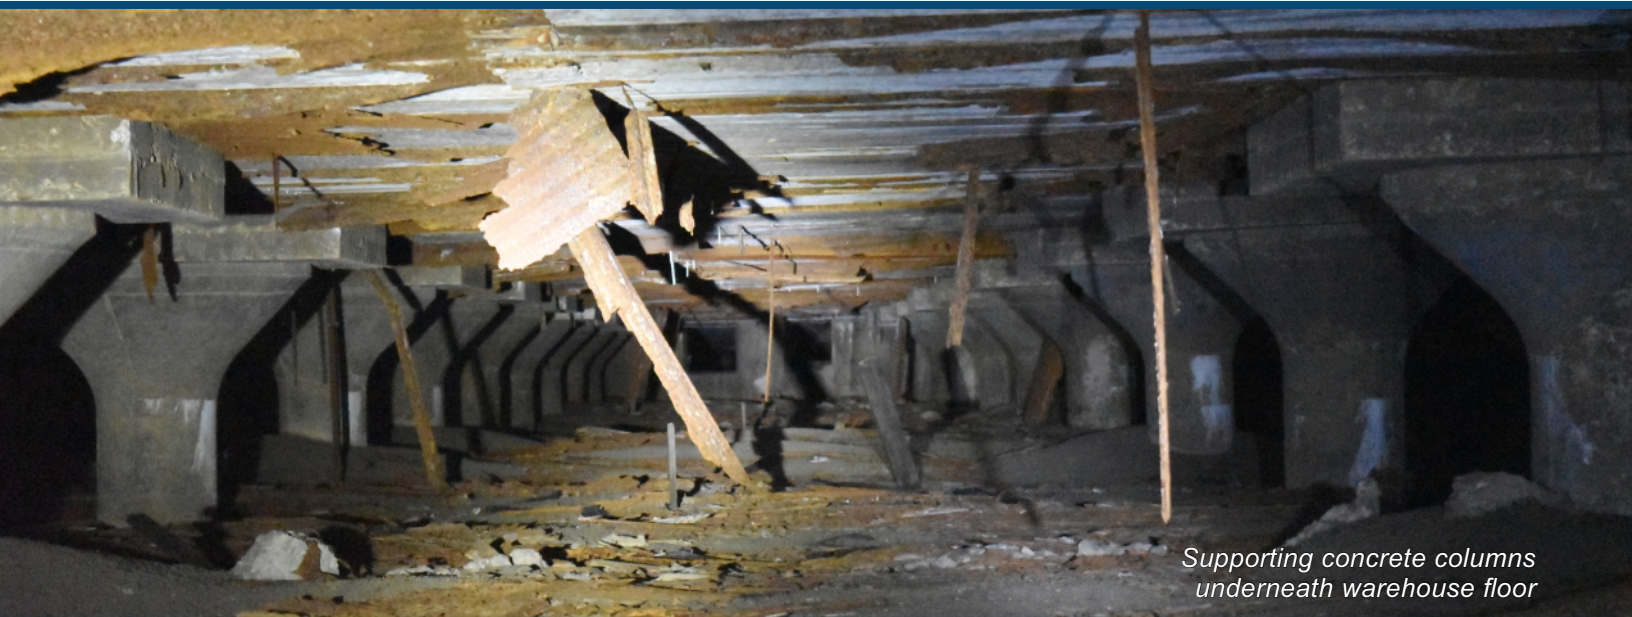
*Supporting concrete columns  
underneath warehouse floor*

ESi inspected the subject warehouses and the shared underfloor ventilation system to assess their design and construction. The warehouse floors consisted of a 3-inch thick concrete slab atop two 4-inch thick layers of foam insulation (i.e. 8 inches of total insulation), supported by a 6-inch thick reinforced structural concrete slab. In the ventilation crawlspace beneath the floor, concrete columns supporting the structural slab above sat on footings buried in the soil below.
