WHITE PAPER

July 4 & 5, 2019 Ridgecrest Earthquake Sequence

Observations from a Post-Earthquake Reconnaissance

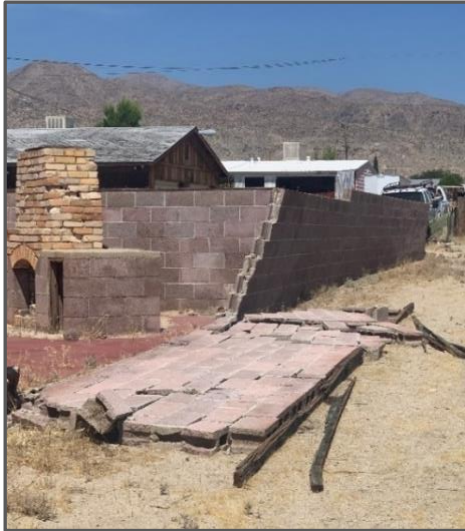
The most obvious structural damage observed in Trona affected unreinforced (or insufficiently reinforced) concrete masonry unit (CMU) walls. Of the failed CMU walls observed, all were only partially grouted and only a few reinforced. Where the walls were reinforced, the reinforcement consisted of plain (undeformed) rebar. Plain rebar is smooth and therefore creates a poor mechanical bond between the bar and the surrounding grout. This condition reduces the tensile capacity of the section and makes the section less capable of resisting overturning forces. This quality of rebar is representative of the era of construction. Since the 1950s, the use of plain rebar has been phased out of new construction in the U.S.

Of the observed partially grouted walls, some cells exhibited vertically placed grout, while others contained no horizontal reinforcement (see Figures 5 and 6). In those cases where horizontal reinforcement was installed, a lack of adequate splice and development length reduced its effectiveness. For these reasons, the horizontal reinforcement failed to tie the grouted cells together contributing to numerous wall failures in Trona.

Figure 5. Damaged block wall observed in Trona. The cells within the blocks were neither filled with grout nor reinforced with rebar.

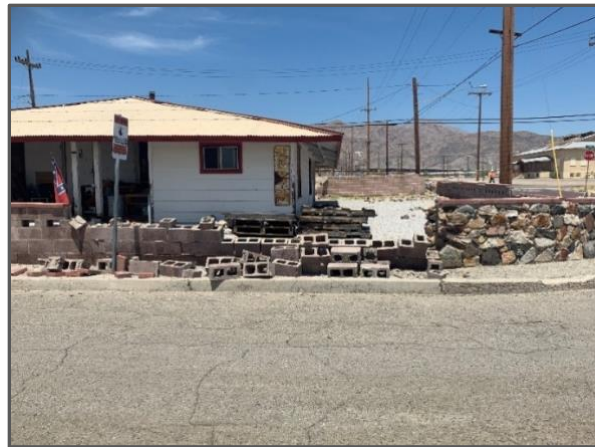
Figure 6. Damaged block wall observed in Trona. The cells within the blocks were neither filled with grout nor reinforced with rebar.

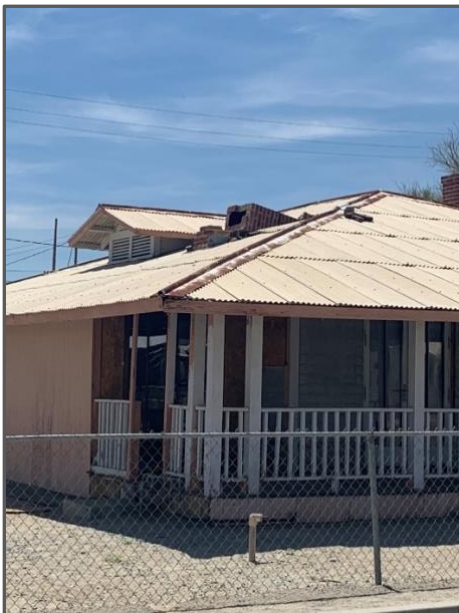
Figure 7. The chimney of this home collapsed and fell through the roof of the structure.

Numerous brick chimneys on the roofs of residential homes also experienced damage during the Ridgecrest earthquake sequence. An example is shown in Figure 7. Brick chimneys are not typically reinforced, so the mortar between the bricks is the only thing holding the bricks together. Because chimneys are located at the tops of buildings, they are prone to higher lateral accelerations (as you move higher on a structure, accelerations increase). The acceleration, coupled with the heavy mass of a brick chimney, creates a large lateral force on the chimney.

These forces can cause the mortar to fail and allow the chimney to collapse. In several instances, the impact from the collapsed brick also caused the roof area around the chimney to fail.

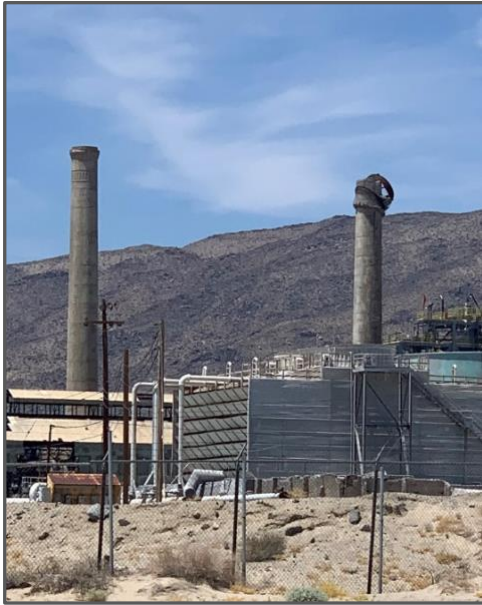
Figure 8. A displaced chimney cap at the top of the smokestack at the Searles Valley Minerals facility in Trona (right side of photo).

One of two smokestacks located on the Searles Valley Minerals facility in Trona also experienced damage in the form of a displaced chimney cap (see Figure 8). Similar to the collapsed residential chimneys, the top of the smokestack experienced higher lateral accelerations from the ground shaking. This type of damage is not particularly surprising in an area affected by a significant earthquake.

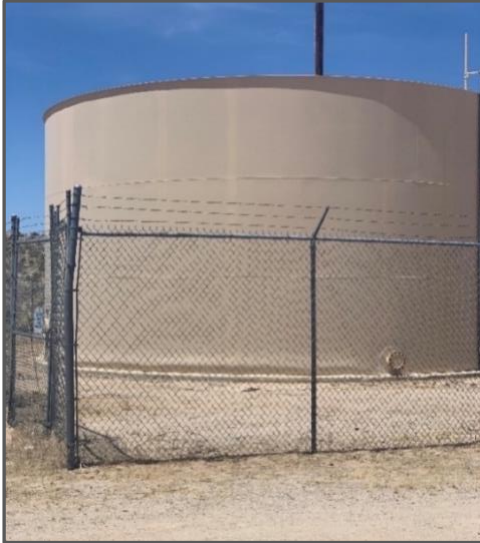
The water tank exhibited buckling at the base (also known as an “elephant foot” failure). The liquid inside the tank and the flexibility of the tank walls tends to amplify the overturning forces on the tank. The side of the tank that is in compression buckles and bulges out when the compression capacity of the tank wall is exceeded. The ground shaking also resulted in the failure of the pipe connection on the opposite side of the tank, resulting in uncontrolled drainage of the tank.

Figure 9. Evidence of an elephant foot failure at the bottom of this water tank located along State Route 178.

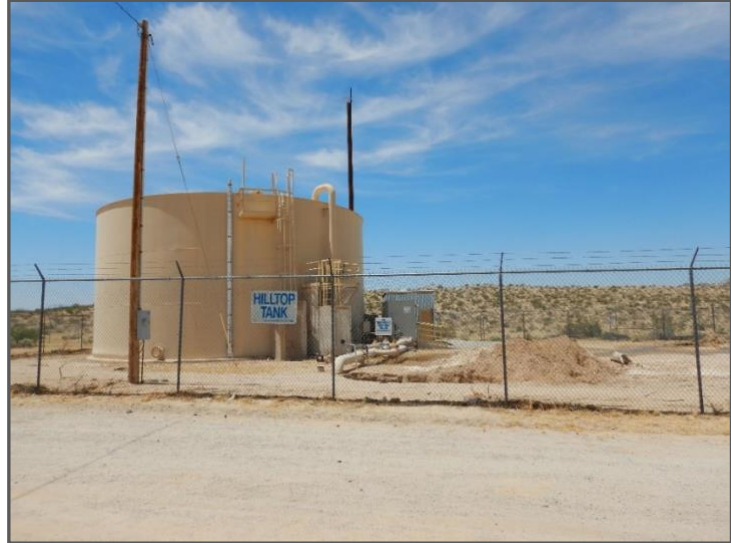
Figure 10. A pipe rupture caused water to uncontrollably flow from the tank. Evidence of the flow path is present on the right side of this photo.

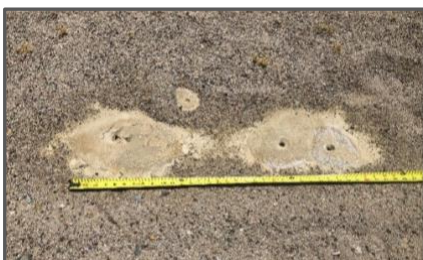
In addition to the cited structural issues, shallow groundwater conditions present near the shore of Searles Lake also contributed to the damage observed in Trona. These conditions facilitated liquefaction and lateral spreading during one or both of the earthquakes. Liquefaction of saturated soils is a complex business, but generally requires a combination of loose soils and prolonged ground shaking in the presence of a shallow groundwater table. Liquefaction of soils is generally associated with larger earthquakes (i.e., M5 and greater), mainly because the process is contingent on the soil column experiencing numerous load cycles, which incrementally increase pore pressures in the soil until liquefaction is achieved. The number of load cycles is a function of the duration of ground shaking, and the duration of ground shaking generally increases with earthquake magnitude.

Figure 11. Sand boils observed along the shoulder of State Route 178 within the Trona city limits. Sand boils are a common surface manifestation of liquefaction.

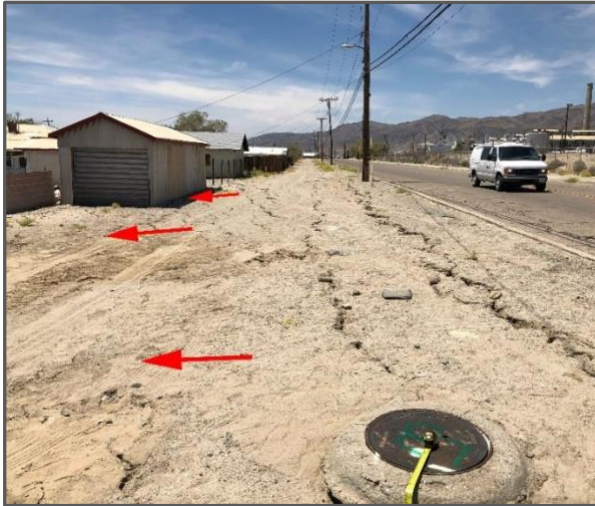
Figure 12. Lateral spreads often accompany ground liquefaction. This phenomenon occurs when drier surficial soils migrate downhill over a liquefied substrate. The spreading can take place on slopes as mild as one degree; in Trona, the affected areas slope about three degrees towards the lake (arrows showing the direction of movement).

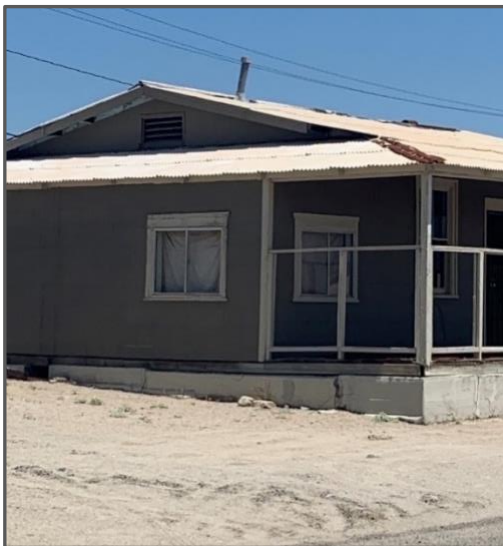
Lateral spreading affected the infrastructure in Trona in numerous ways, including damaging streets and sidewalks, shattering buried sewer and water lines, and destabilizing power poles. Liquefaction-induced lateral spreading also caused slab-on-grade foundations to crack. Figures 12 through 14 show examples of the damage that resulted from lateral spreading in Trona.

Figure 13. Lateral spreading in Trona caused damage to the foundation of this home. Ground movement occurred from left to right in this image.

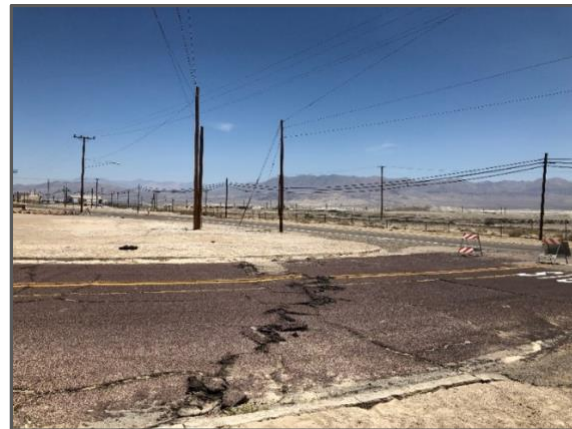
Figure 14. Cracks in the asphalt roadway resulted from some of the instances of lateral spreading that occurred in Trona.

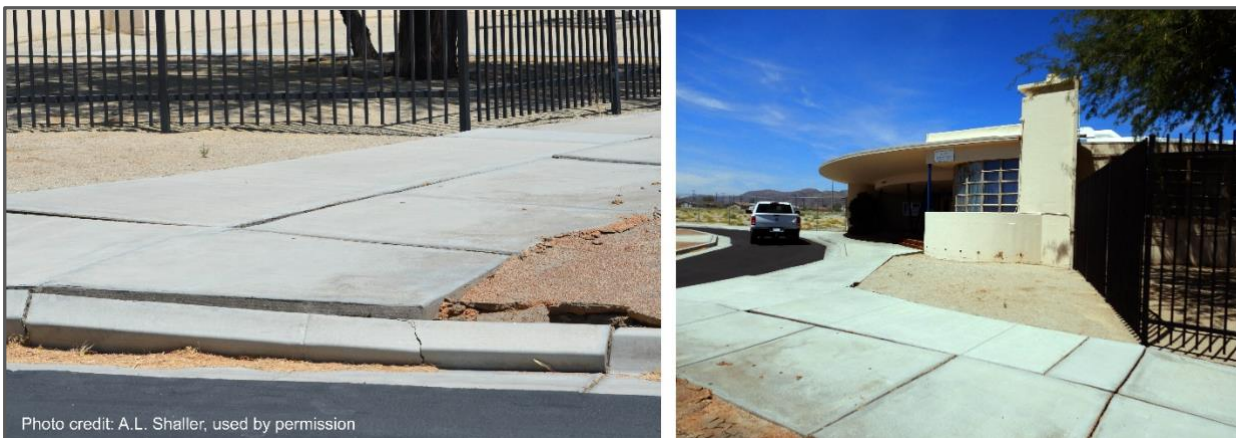
Figure 17. The concrete sidewalk in front of Trona High School showed evidence of lateral spreading.

Figure 18. The concrete sidewalk in front of Trona High School showed evidence of lateral spreading.

The commendable performance of Trona High School (built in 1941) highlights the continuing benefits derived from the landmark 1930s legislation. Despite ground shaking intensities of 6 to 7, ground accelerations of about 0.2 g (about 20 percent as high as the acceleration of gravity), and obvious indications of lateral spreading adjacent to the structure, the original school building apparently performed well in the earthquake sequence.

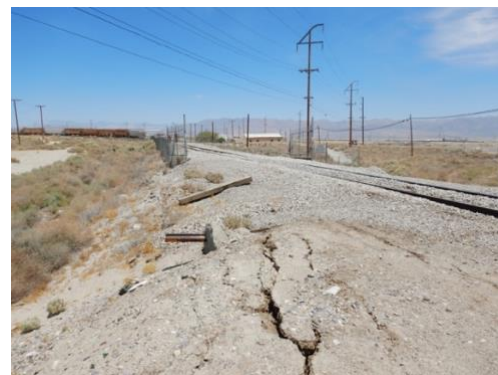
In addition to road and pipeline damages, a private railroad line owned by Searles Valley Minerals also suffered damage, as evidenced by lateral spreading in the railroad embankment, disturbed ballast, and misalignment of the rails.

Figure 21. Private railroad line damage.

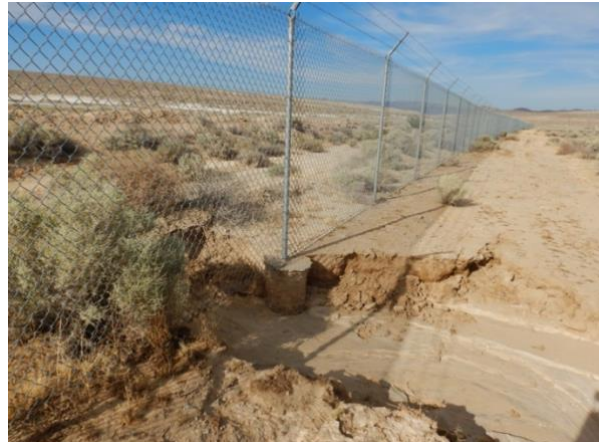
Figure 23. Evidence of scour downslope from one of the ruptured water lines along Highway 178.

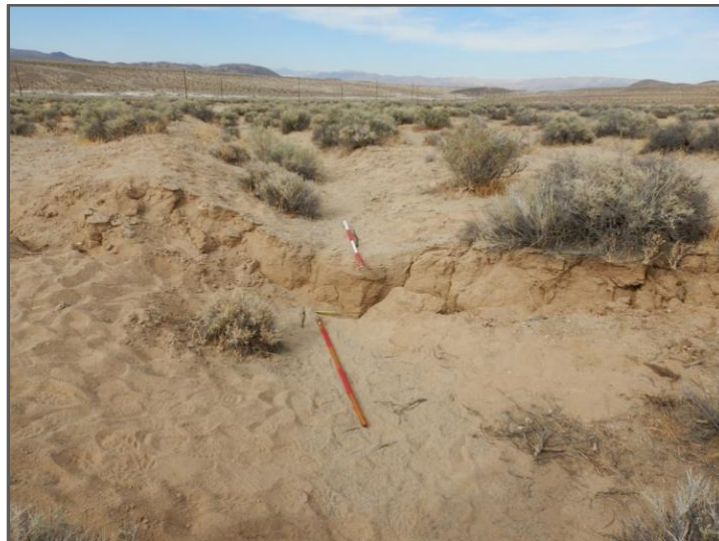
team found a scarp with an ~18 inch drop and an ~18 inch right-lateral strike-slip² offset, resulting in the misalignment of at least one pre-earthquake channel invert that will cause a diversion of runoff in future storms. Although an 18-inch fault displacement sounds large, the fault experienced as much as 8 feet of offset on portions of the Naval base. Much larger single-event fault offsets have been recorded on other fault lines in the past; as much as 40 feet (horizontally) along the San Andreas fault in Central California and 20 feet (vertically) along the Owens Valley fault zone, as an example. Displacements of this magnitude leave long-lasting scars on the landscape that affect drainage patterns for generations. For example, the cited vertical offset along the Owens Valley fault zone, which accompanied the great 1872 Lone Pine earthquake, created a graben (i.e., an elongated, fault-bounded depression) that filled with spring water, forming Diaz Lake which is located on the south side of the town of Lone Pine off Highway 395. Today, the lake is a popular recreational area, with boating, fishing, water sports, picnic grounds, camping, and trails. Earthquakes can certainly destroy, but they can also create new and attractive landscapes that can be enjoyed for generations to come!

Figure 26 View to the northeast along the flowline of a narrow channel offset ~18 inches vertically and horizontally by the fault scarp of the July 5 M7.1 earthquake. The two measuring staffs mark the offset sides of the channel invert.
