## FROZEN IN TIME: UNDERSTANDING THE MECHANICS OF A CRYOGENIC LOSS

A liquid nitrogen cryogenic freezer failed due to a defect in the electronics and specimens were lost due to operator error and a failure to properly follow procedures. Through data analysis and testing, a defect in a different supplier's component was determined to be the cause.

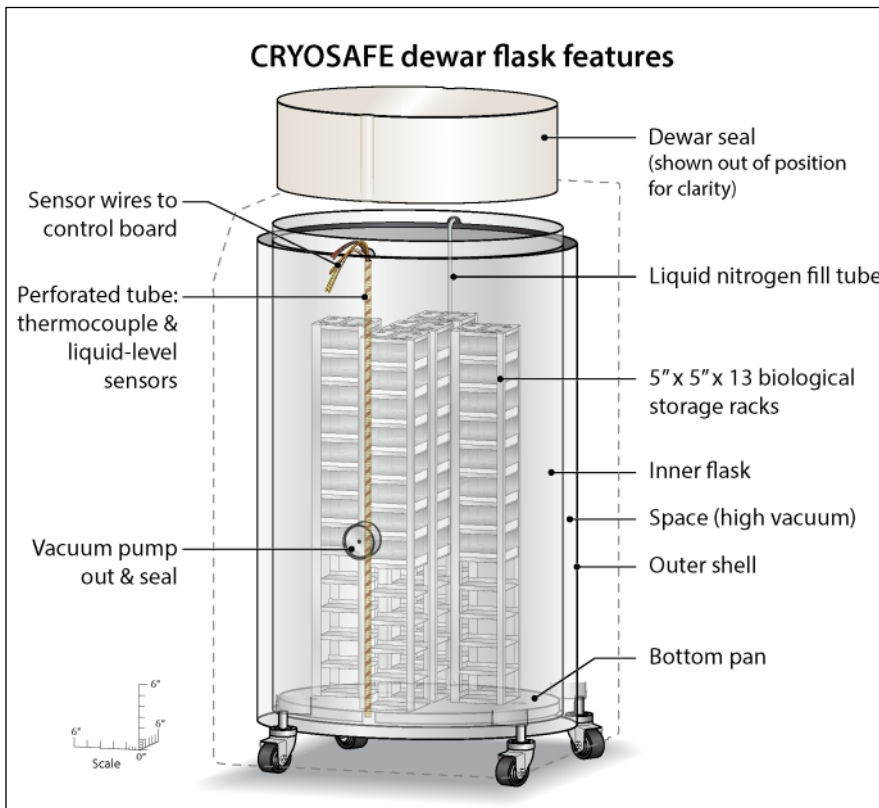
After extensive testing of other components in the freezer and further analysis ESi discovered that a different supplier's component in the freezer was at fault for the initial failure. In particular, there was a defect in the control board that stopped the automatic fill cycle when the electronics were subjected to an electric surge at a precise time during its software execution. This failure mode was repeatable and consistent with the facts of the case. Further, operator error and a failure to properly follow procedures, including people manually monitoring the freezer also contributed to the failure.
