ALLEGED HAND CRUSHING INJURY AT GROCERY STORE

ESi conducted a site inspection at a grocery store's bottle return area and compared force and speed measurements of a swinging door with published literature to determine that the incident in question would not have happened in the manner described, ultimately resulting in a favorable settlement for ESi's client.

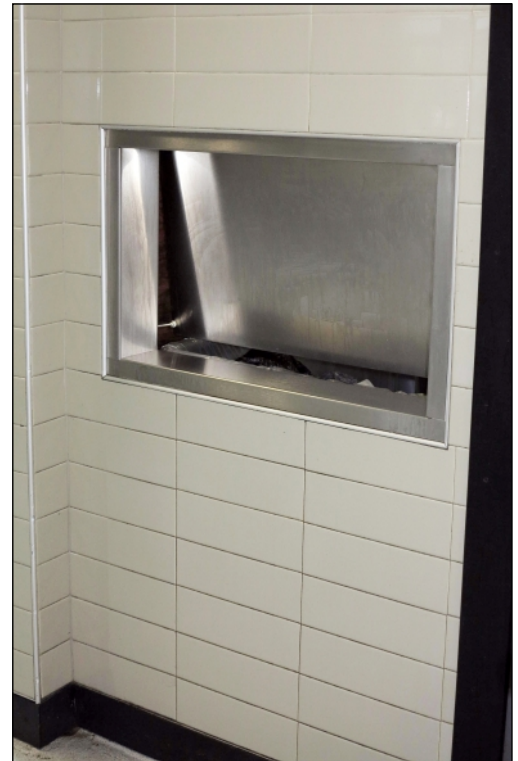
Geometric measurements of the window area, frame, and metal door were obtained, and it was discovered that the size and alignment of the components created a $\frac{5}{8}$ inch vertical gap between the window frame ledge and the bottom of the closed metal door. Video footage of the freely closing door was recorded to quantify the closing speed. The average time for the door to close from a fully open position to a closed position was 375 msec. A force gauge was used to measure the weight of the metal door and the dynamic force imparted by the door swinging closed. The peak impact force of the door fully closing was measured to be no more than 15 pounds.

The examination of the subject components provided an understanding of how the $\frac{5}{8}$ inch vertical gap would affect the interaction between the closing door and a hand if resting on the window ledge. This gap limited the extent to which the hand can be pinched directly between the door and the frame. Hand movement and reaction time data in the literature showed that the 375 msec necessary for the door to close is similar to, or less than, the time for aware research subjects to move their hand less than half of the distance described in the subject incident. One injury threshold research study concluded that volunteers categorized a door closing on their extended hand with a force of 45 pounds to be “bearable” and did not cause injury in any of the participants. The force associated with the subject closing door was one-third of the “bearable”, non-injurious force.
