news of engineering forensics

MDE Inc.

Understanding and Addressing Microbiologically Influenced Corrosion (MIC) Issues

by Randy K. Kent, M.S., P.E.

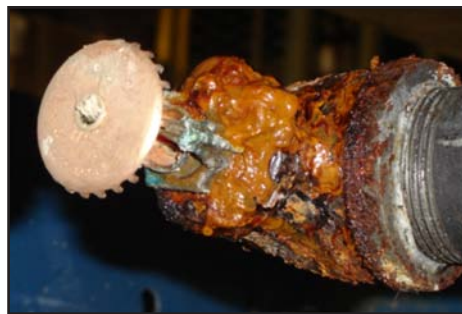
Water sample tests can identify the presence of MIC forming bacteria and the presence of a corrosive environment; however this testing does not reveal the degree of corrosion. The best way to confirm that MIC has degraded piping is to remove sections for evaluation by a microbiologist and metallurgical engineer. Pipe section evaluation has another advantage

in that other types of pipe corrosion can also be found, and the corrosion progression can be determined.

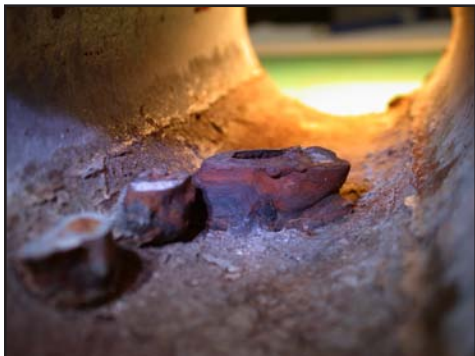
The key to preventing a catastrophic failure due to MIC is routine inspections and testing of systems exhibiting MIC symptoms. Early detection of MIC bacteria, slimes, or water properties that are conducive to MIC bacterial growth or other general corrosion may provide for timely correction. Inspecting the inside of the pipe with

a video bore scope is helpful in understanding the magnitude of the problem. If this is done, it is recommended that the scope work be video taped so other professionals can later analyze the piping and give appropriate direction. Corrective measures may include chemical treatment of the water, flushing, chemical or mechanical cleaning, and killing of microbes on the pipe interior. Once MIC or other types of corrosion have progressed to the point of leaks and significant pipe wall thinning, the pipes must typically be replaced -- which can be very expensive and disruptive to the building operations. With a new system, the initial fill can be with treated water, biocides and corrosion inhibitors. An existing system may have treated water added when the system is flushed and filled after annual maintenance.
