# news of engineering forensics

## Plastics Piping Forensics

by Keith G. Cline, P.E.

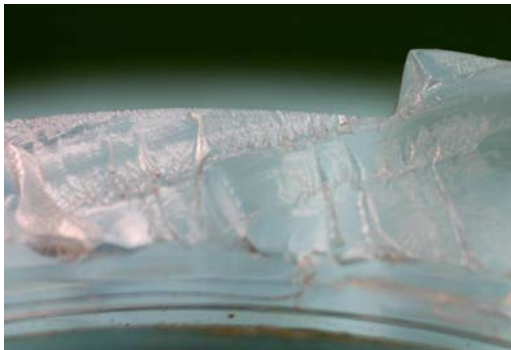
Microscopic view of water filter failure

MDE's scanning electron microscope (SEM) is used to determine the fracture initiation location and the fracture type (e.g. brittle, ductile, fatigue). Manufacturing defects, installation damage and service induced cracking can be properly identified with the SEM. Additionally, the attached energy dispersive x-ray analyzer (EDS) can identify chemicals present that may have caused the failure.

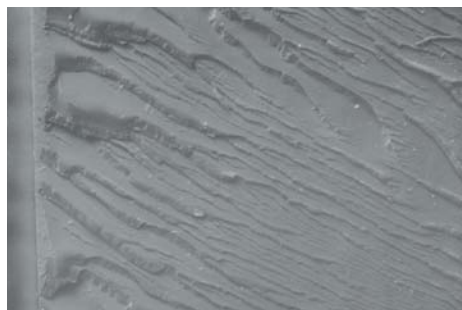
SEM of water filter failure
